Fractura coronae dentis Tooth 21

A 10-year —old boy suffered an injury 3 days earlier, hospitalized due to suspicion of concussion. After leaving the hospital, he came to my office with his father.

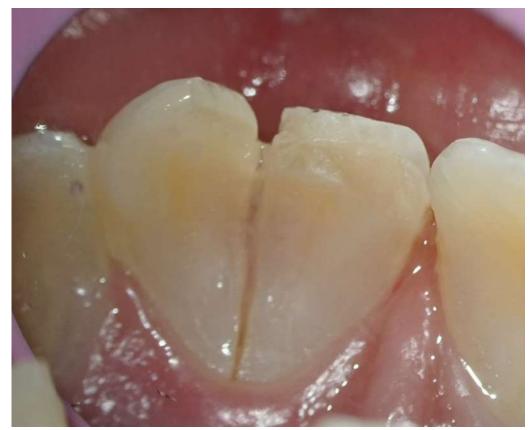
Palatal view

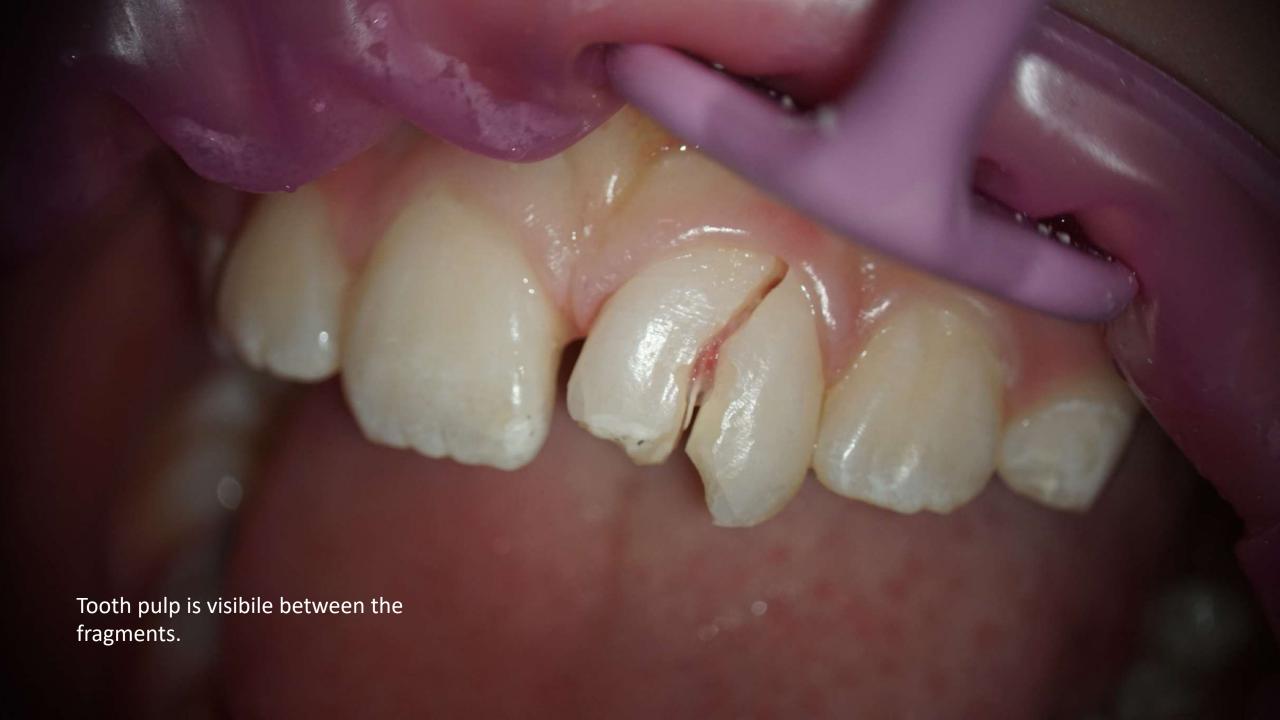
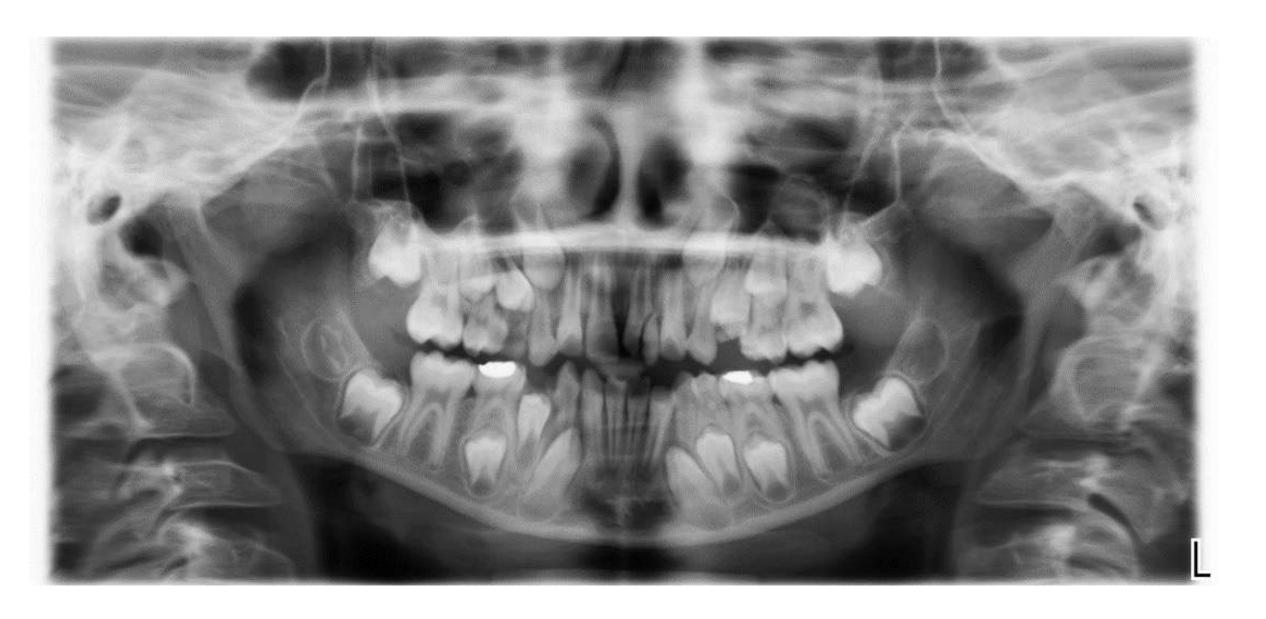
Panoramic radiograph taken 3 days after the injury.

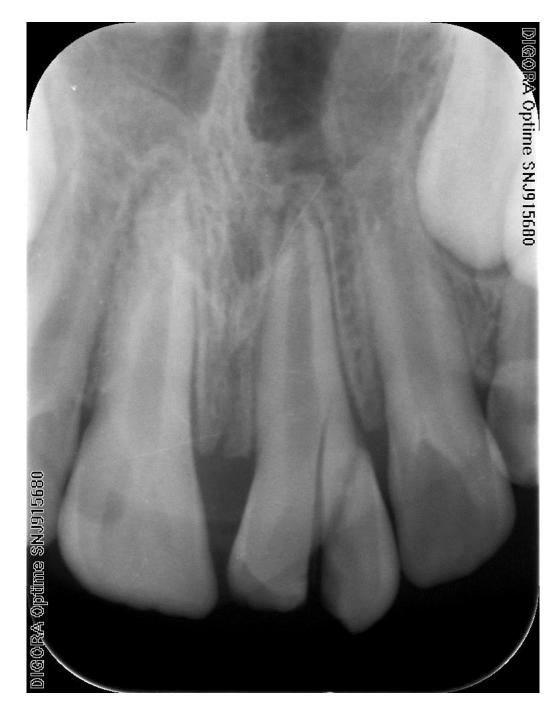
Tooth 21 Radiological examination revealed an oblique subgingival fracture through the pulp chamber. Two fracture lines are visible.

Possible treatment (wg J.O Andreasen):

- 1. Removal of the fractured fragment and surgical exposure of the subgingival fracture,
- 2. Removal of the fractured fragment and orthodontic extension,
- 3. Removal of the fractured fragment and surgical tooth extrusion,
- 4. Tooth extraction.

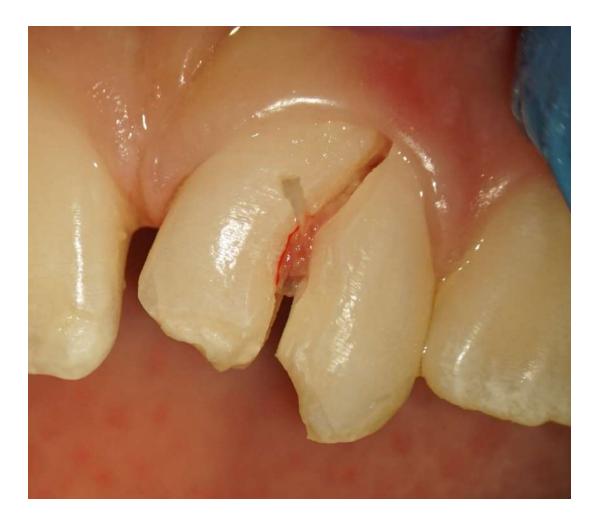
On the labial side, the damage to the tooth is greater with cavities in enamel and dentin.

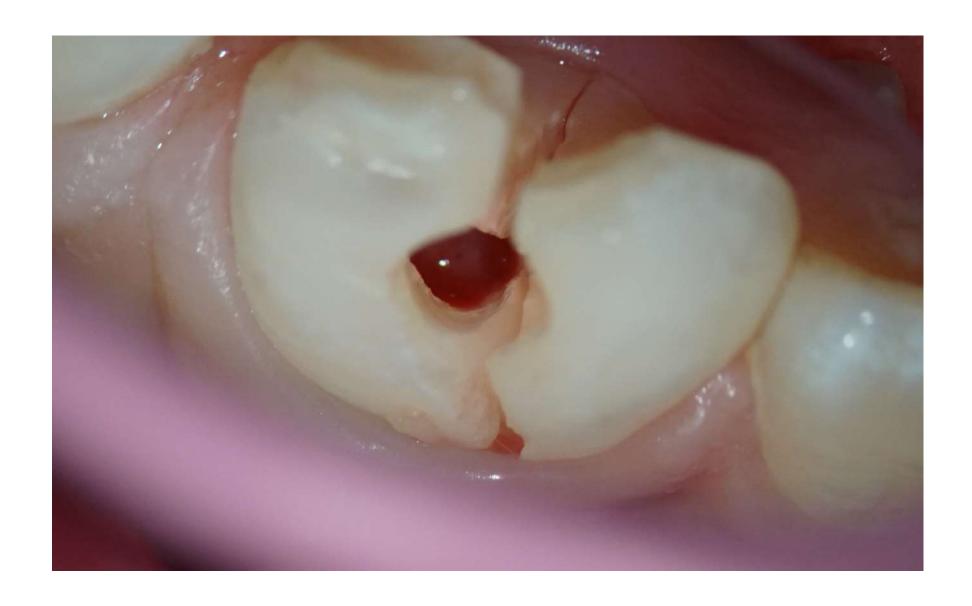
Pulp without visible inflammatory features.

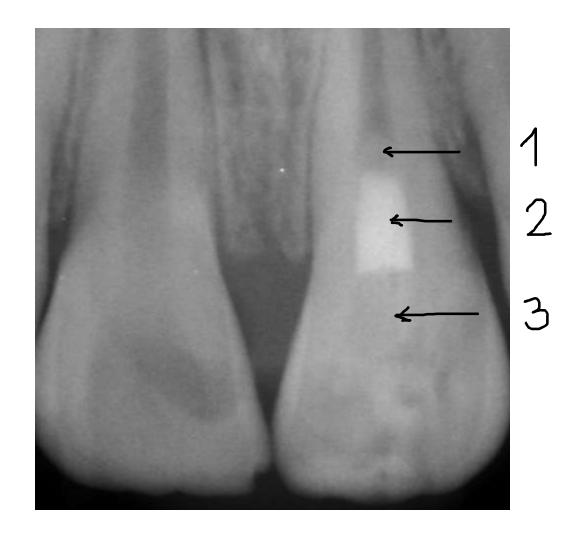
- 1. Dentinal brigde
- 2. Total Fill
- 3. EverX-D, G-aenial A1

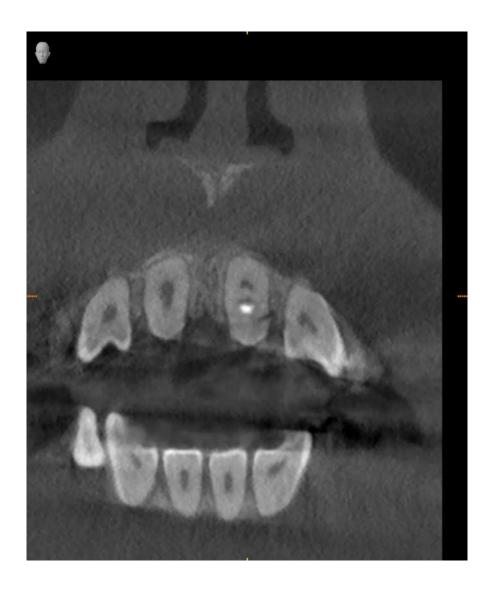
CBCT FOV 5cmx5,5cm. Axeos (Sirona)

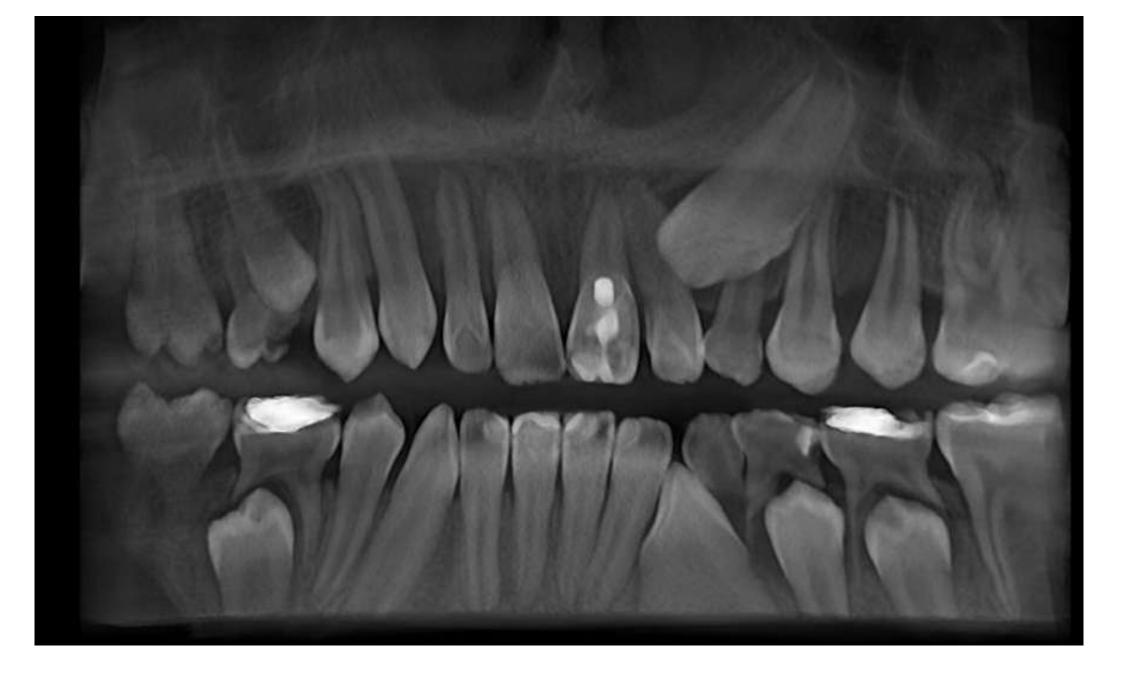
CBTC FOV 5cmx5,5cm Axeos (Sirona)

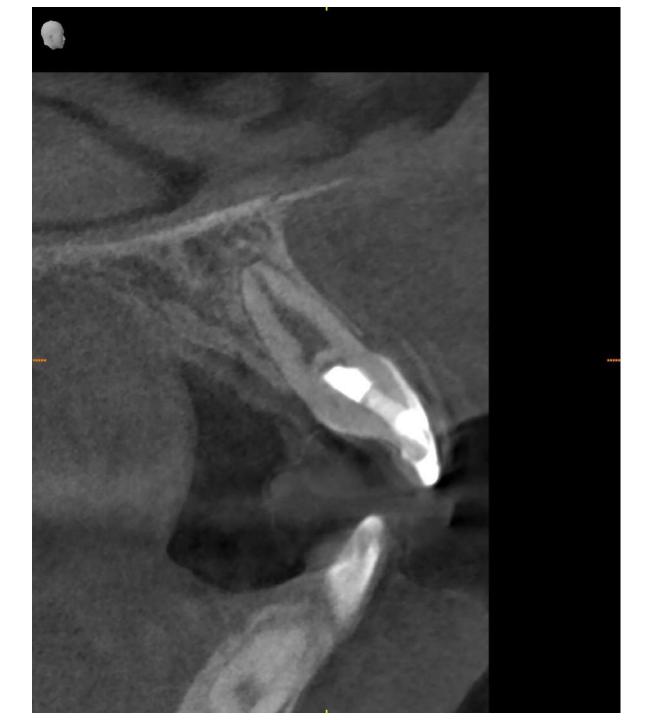
CBCT FOV 5cmx5,5cm Axeos (Sirona)
