Immediate replantation

Gabriela Opolska

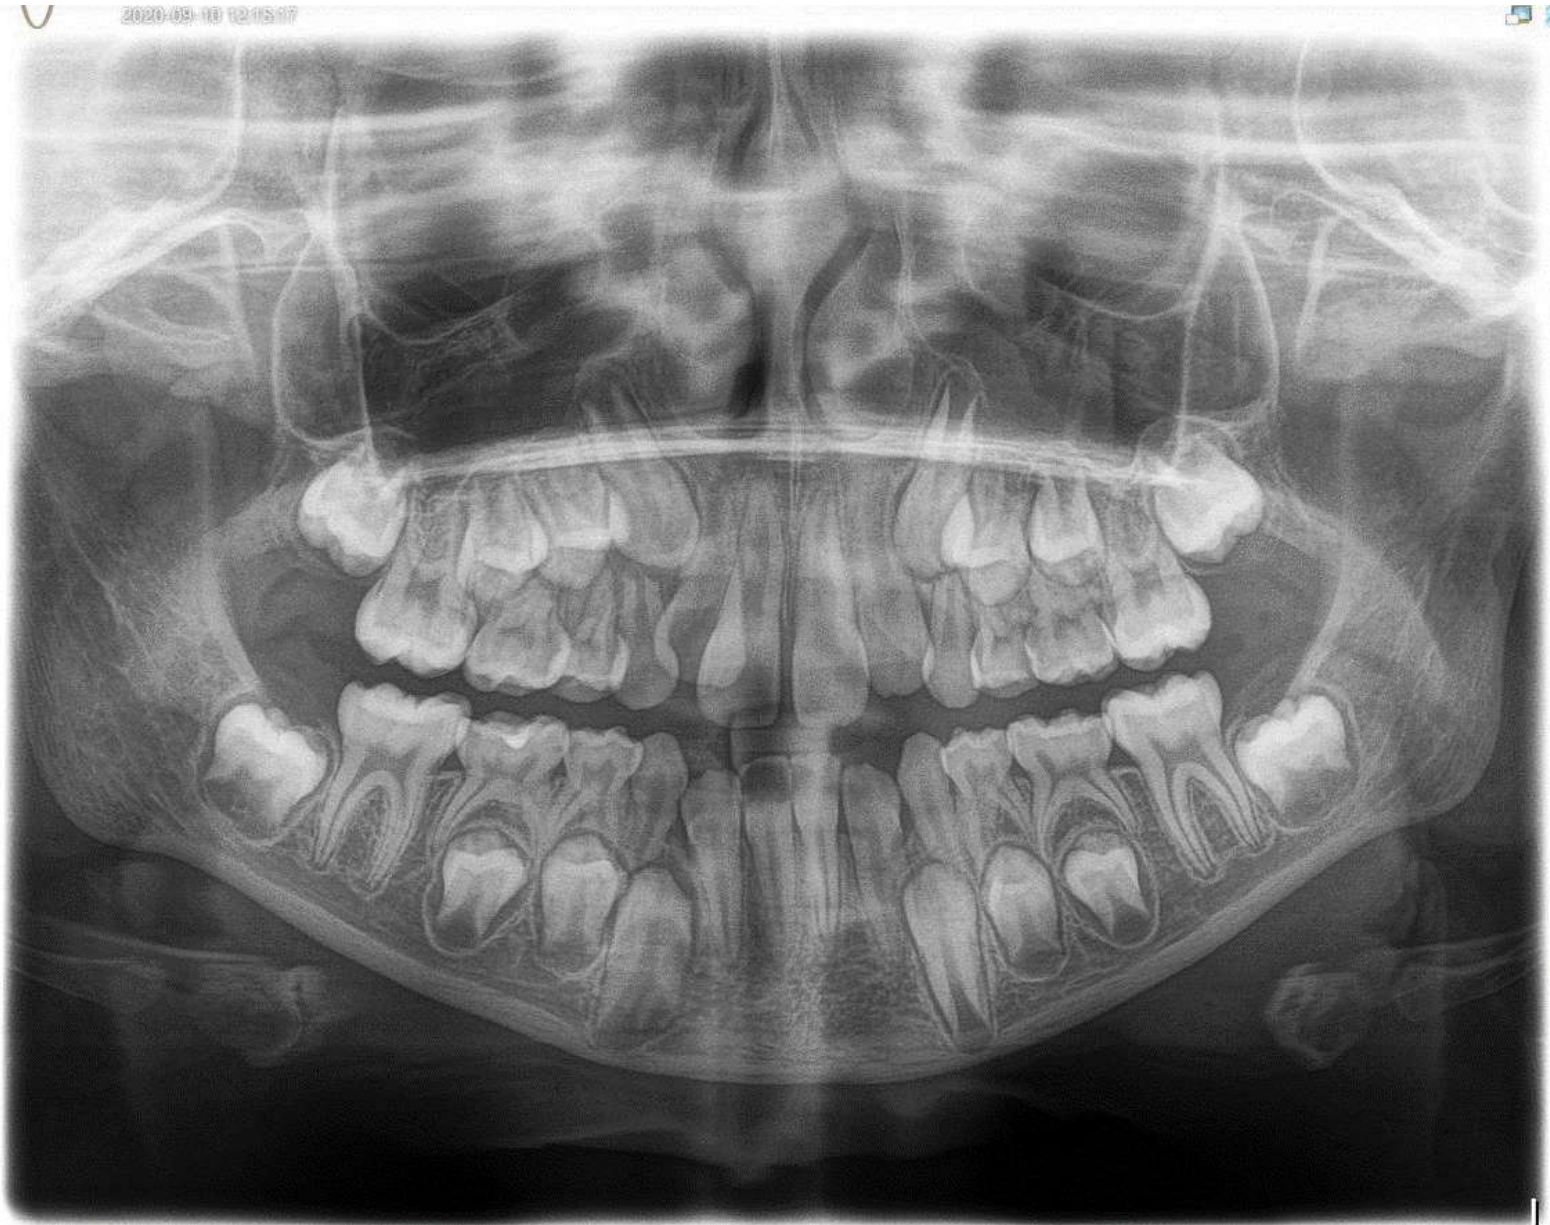
State before the injury

A 10-year-old patient , during orthodonttic treatment.

A face was injured as a result of the explosion of the fuse box.

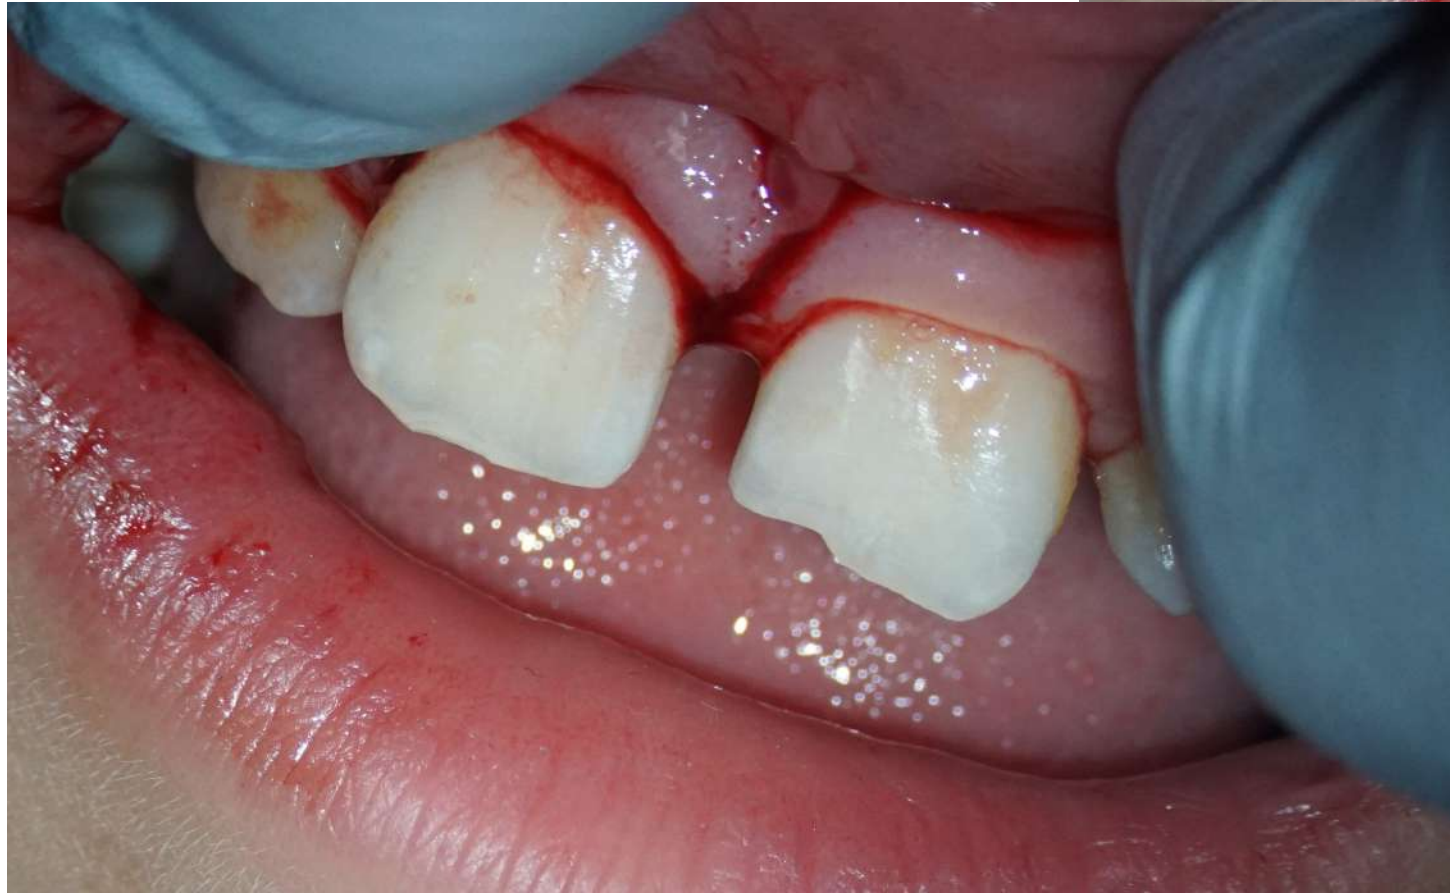
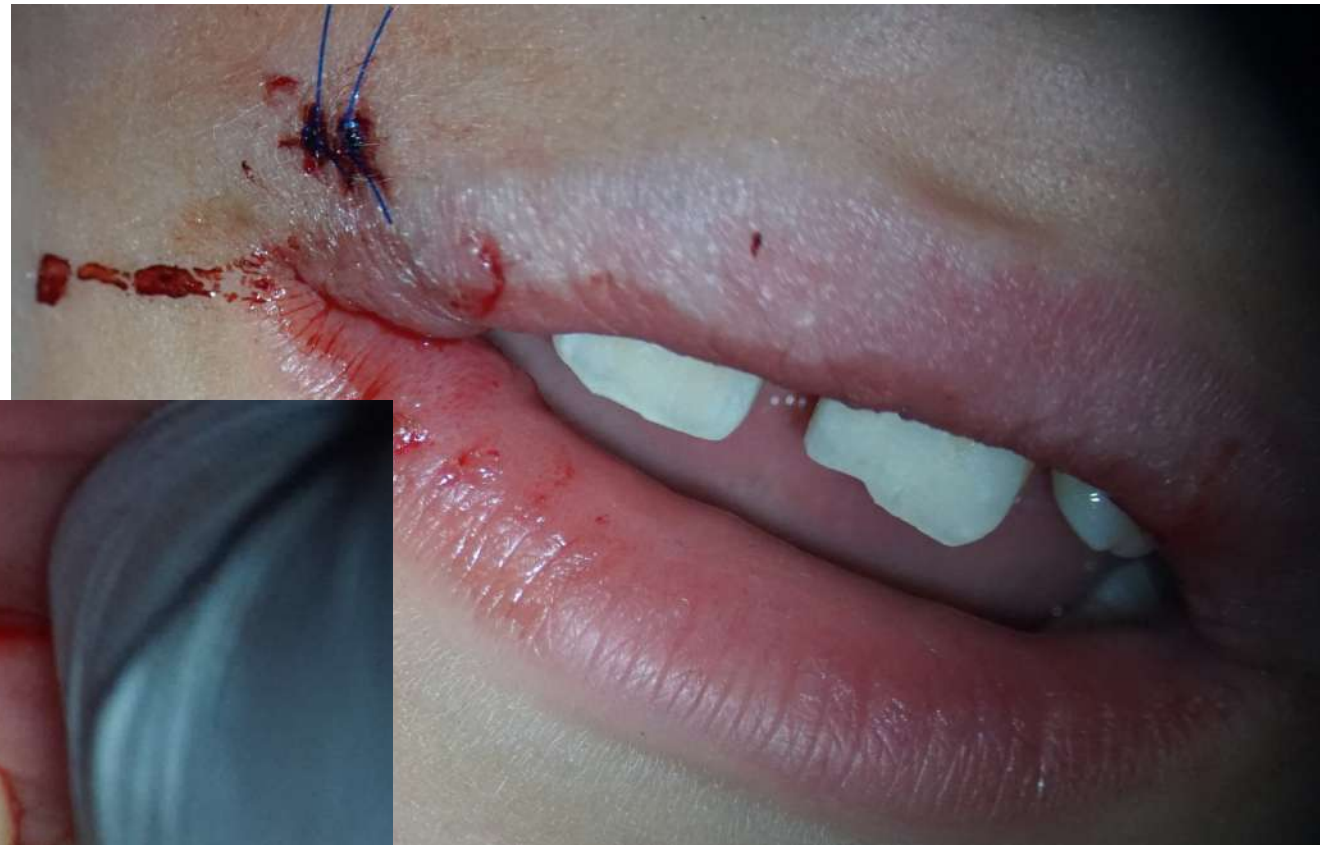
State after the injury

As a result of the injury, tooth 11 was completely dislocated and the crown tooth 21 was fractured without the pulp being exposed, and tooth was partially dislocated.

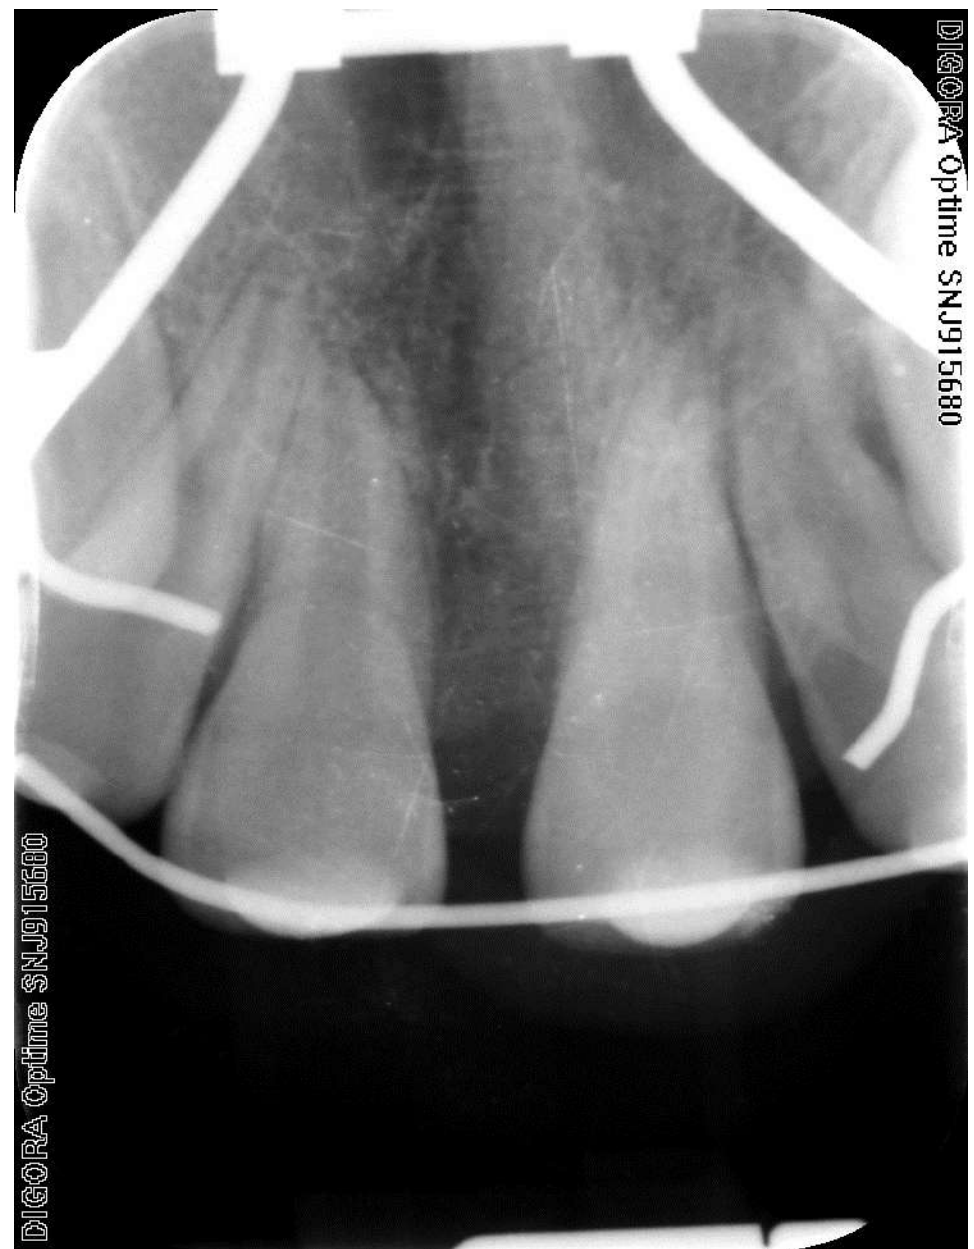
After reposition , a semi-rigid bond was established.

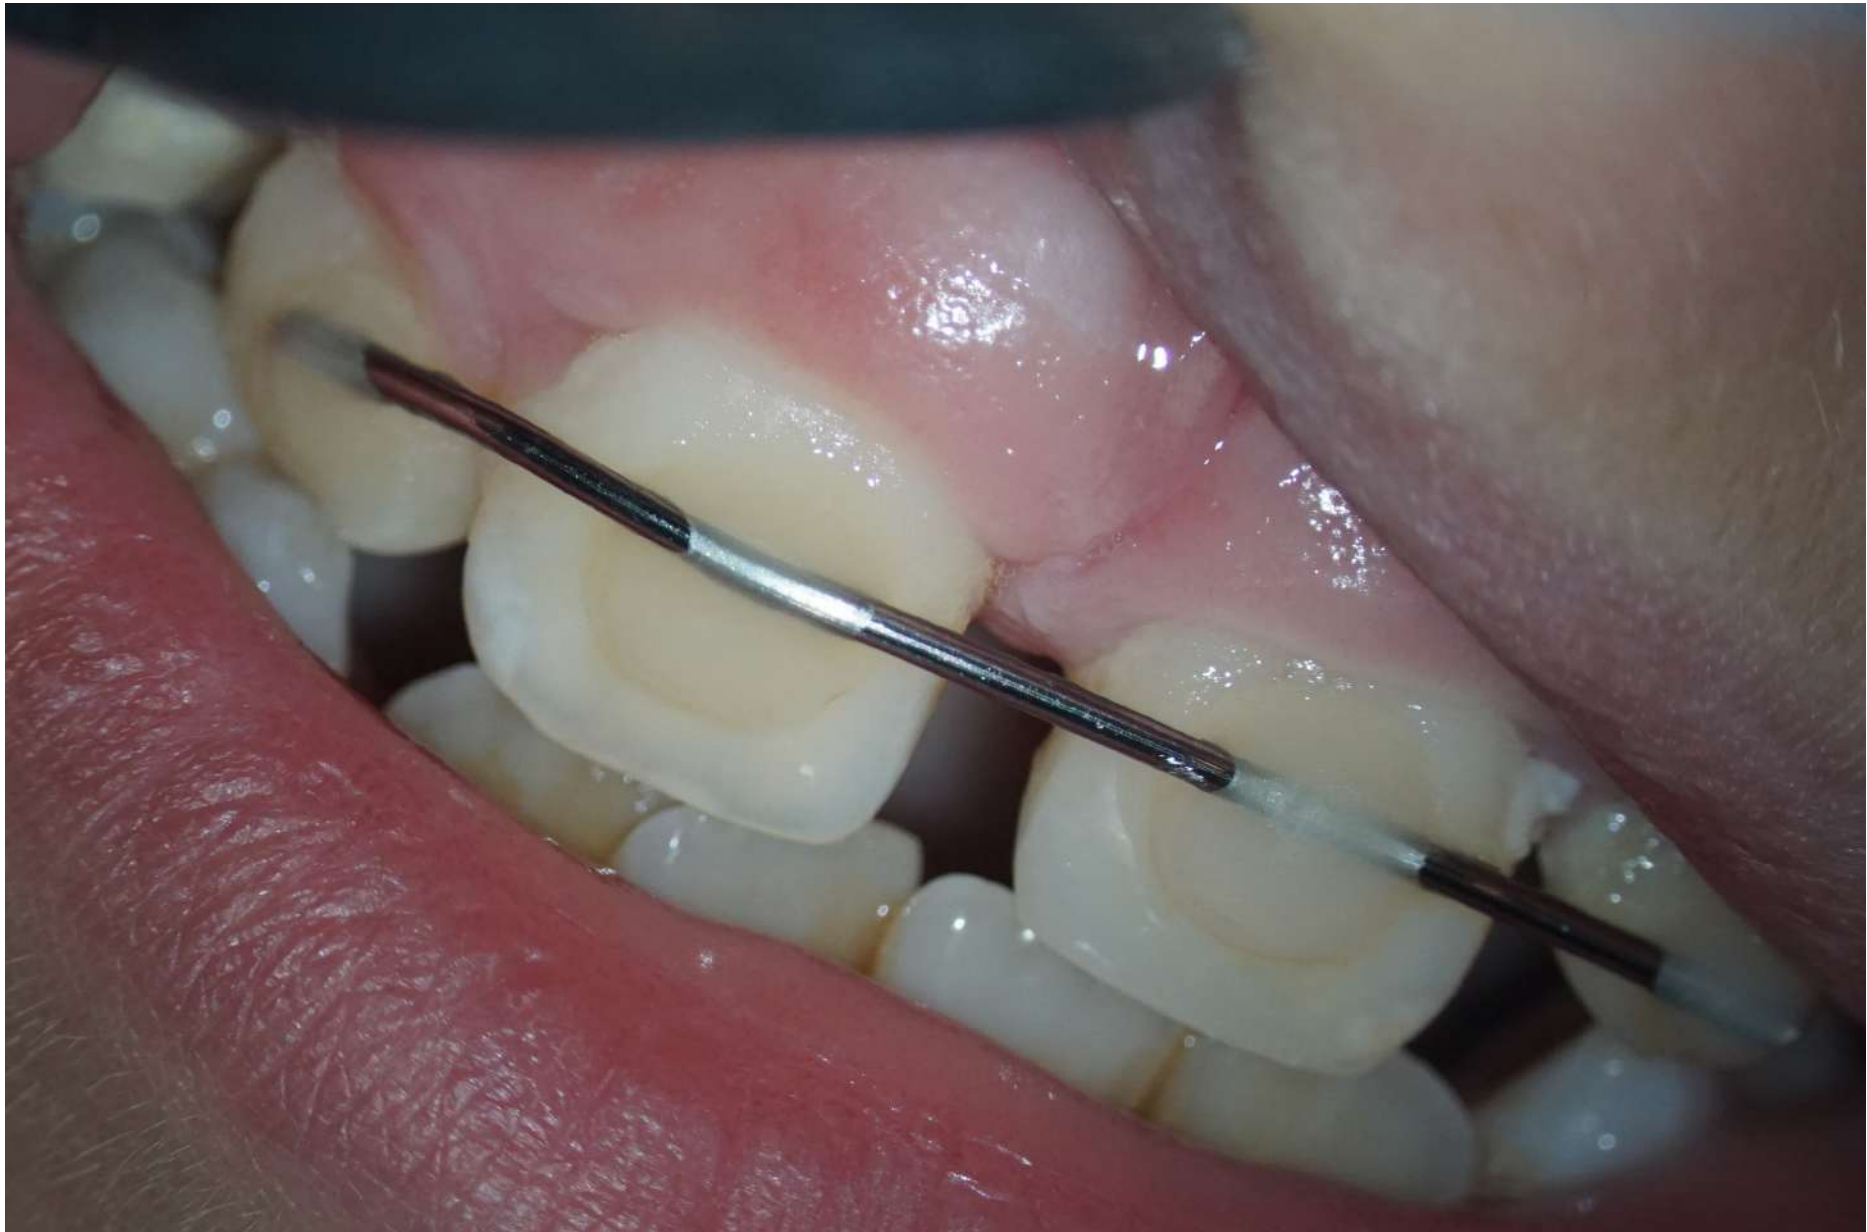
After a week, 6,0 sutures were removed.

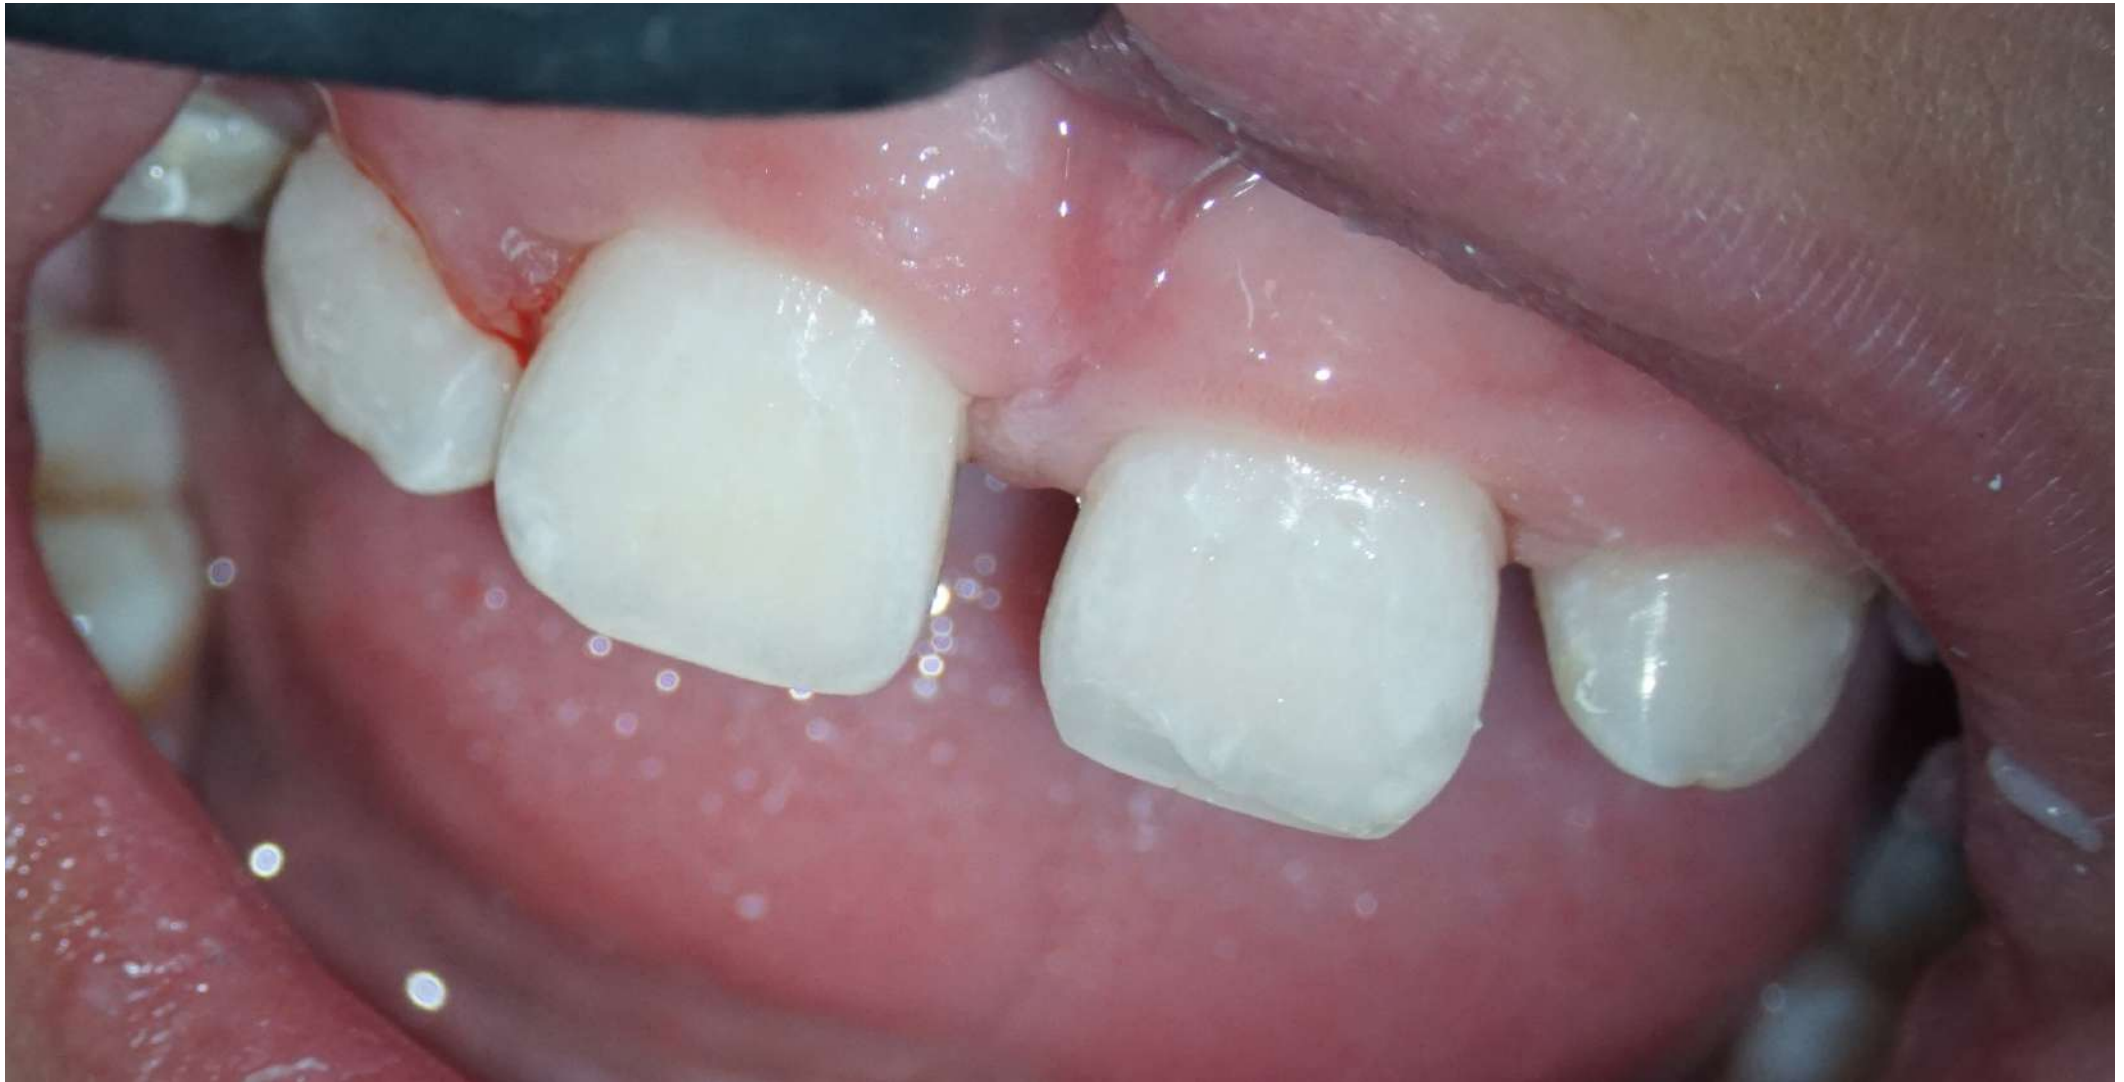
After a week, the ligature was removed. Slight mobility of both central incisors.

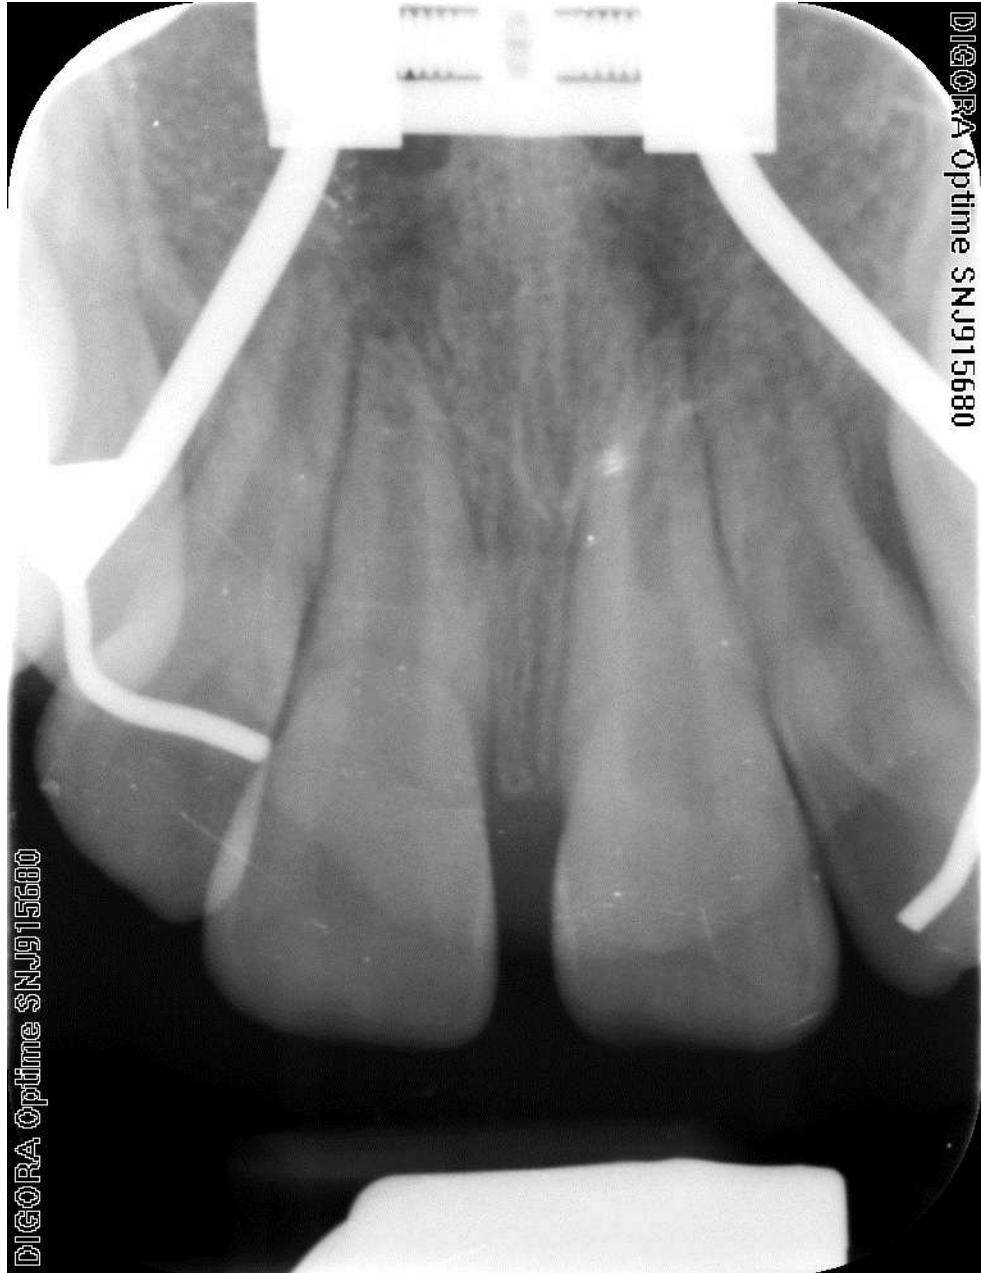
Due to the quarantine for covid 19, the patient missed subsequent follow-up visits.

She came back 2 months later, that is 4 months after the injury.

Pulp viability testing with pulptester was at a similar level of 5-6.

Cold test was positive in all teeth.

However, radiographically, changes were visible in the apical area of the canal in tooth 11, which may suggest the beginning of internal root resorption.

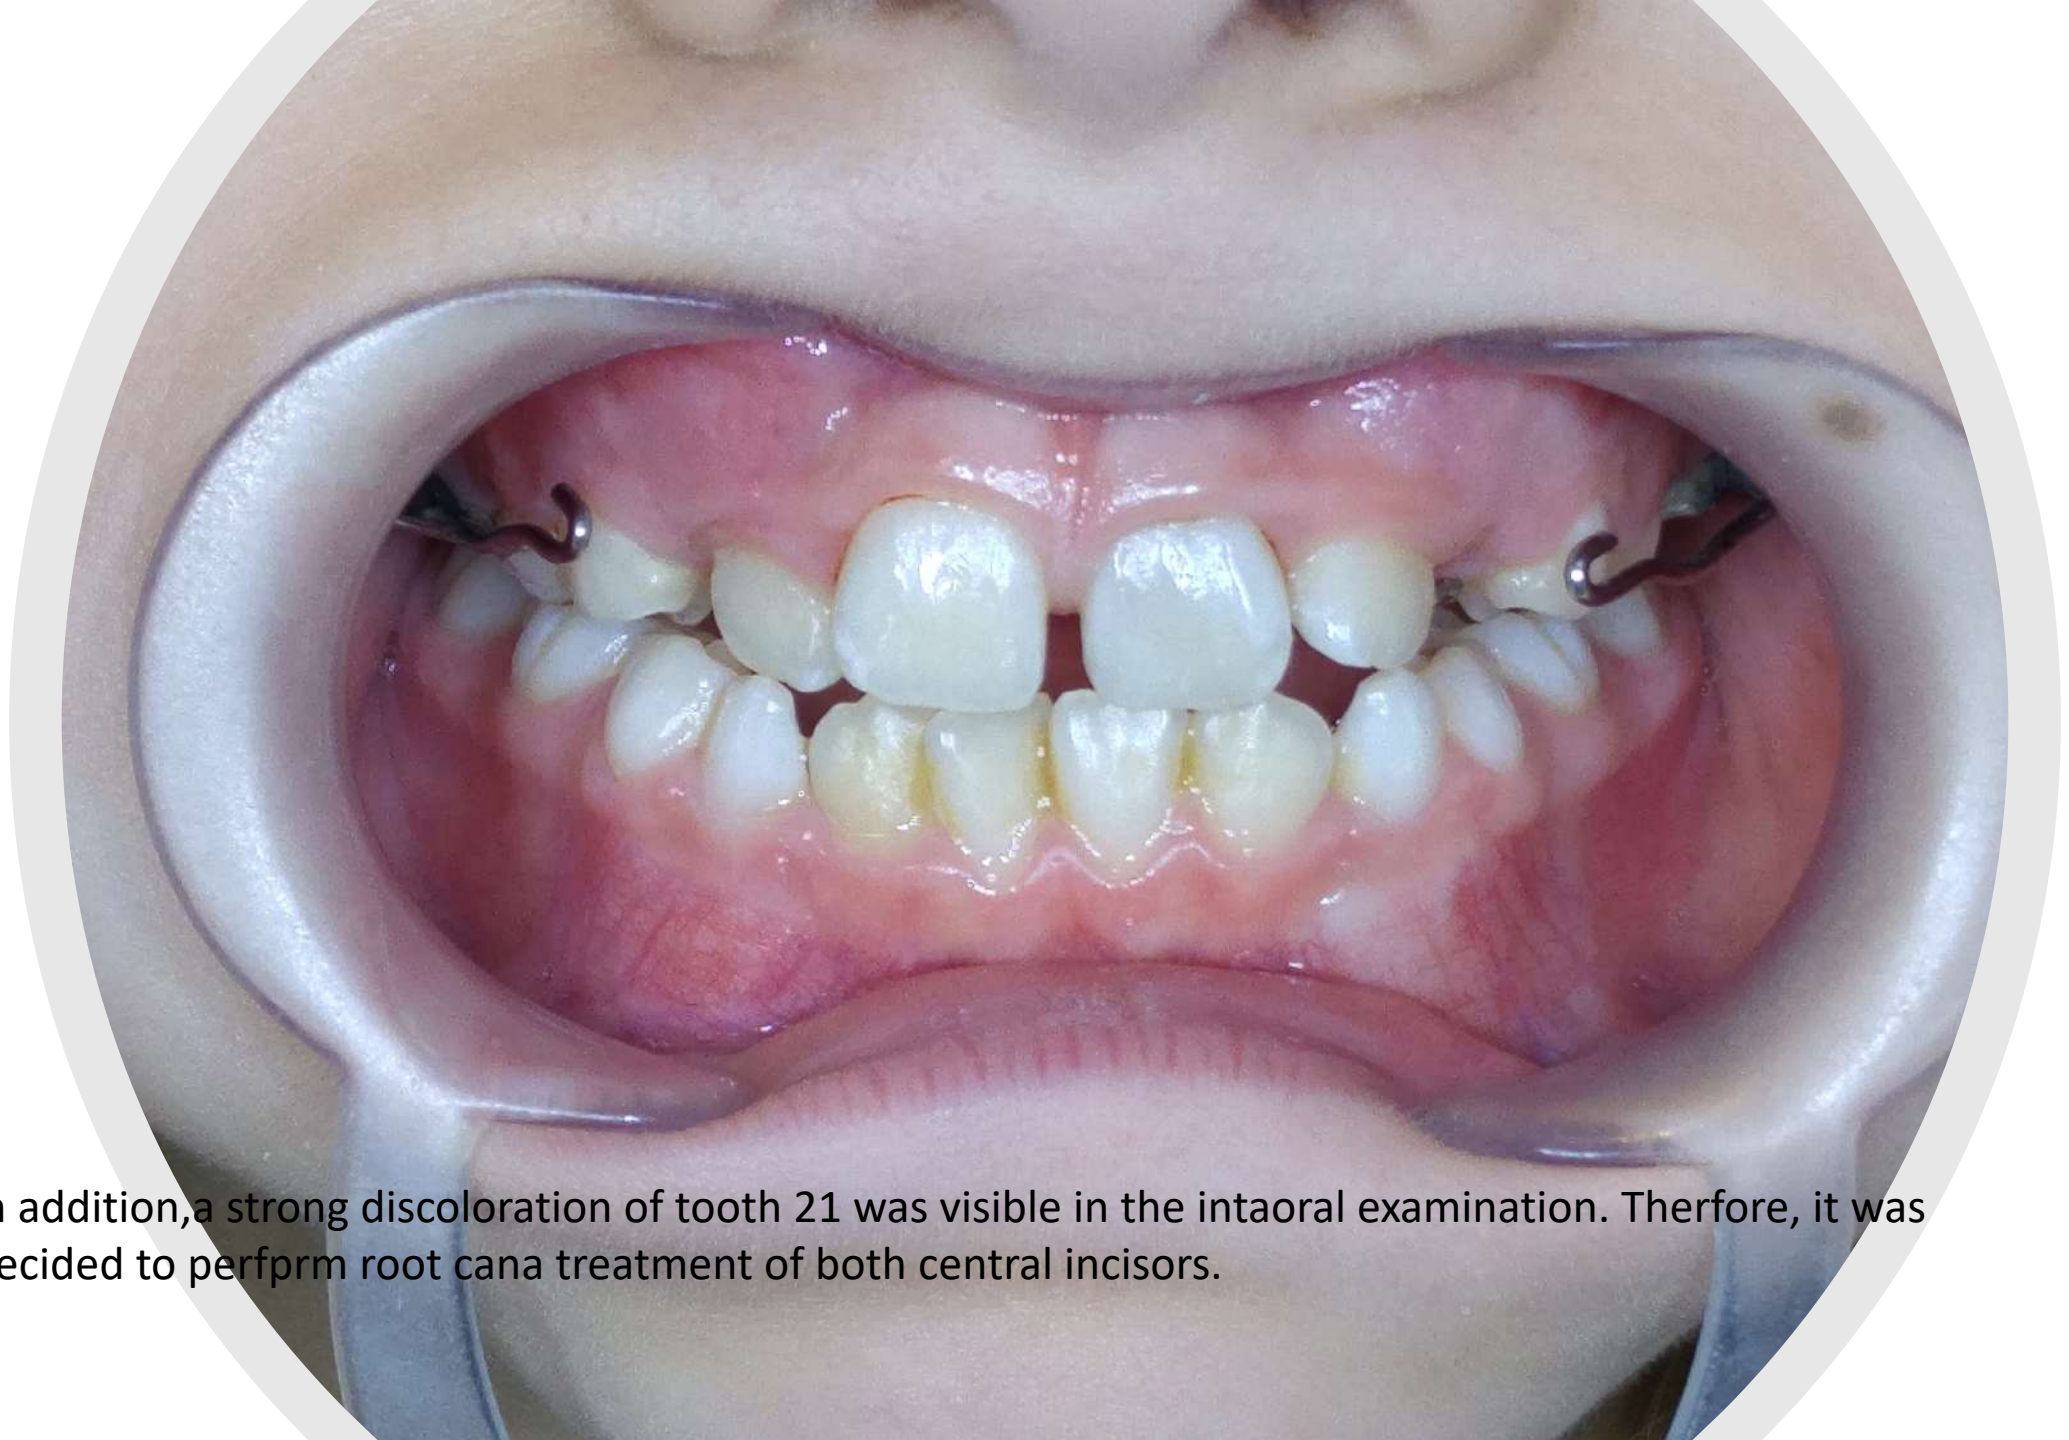
In addition, a strong discoloration of tooth 21 was visible in the intraoral examination. Therefore, it was decided to perform root canal treatment of both central incisors.

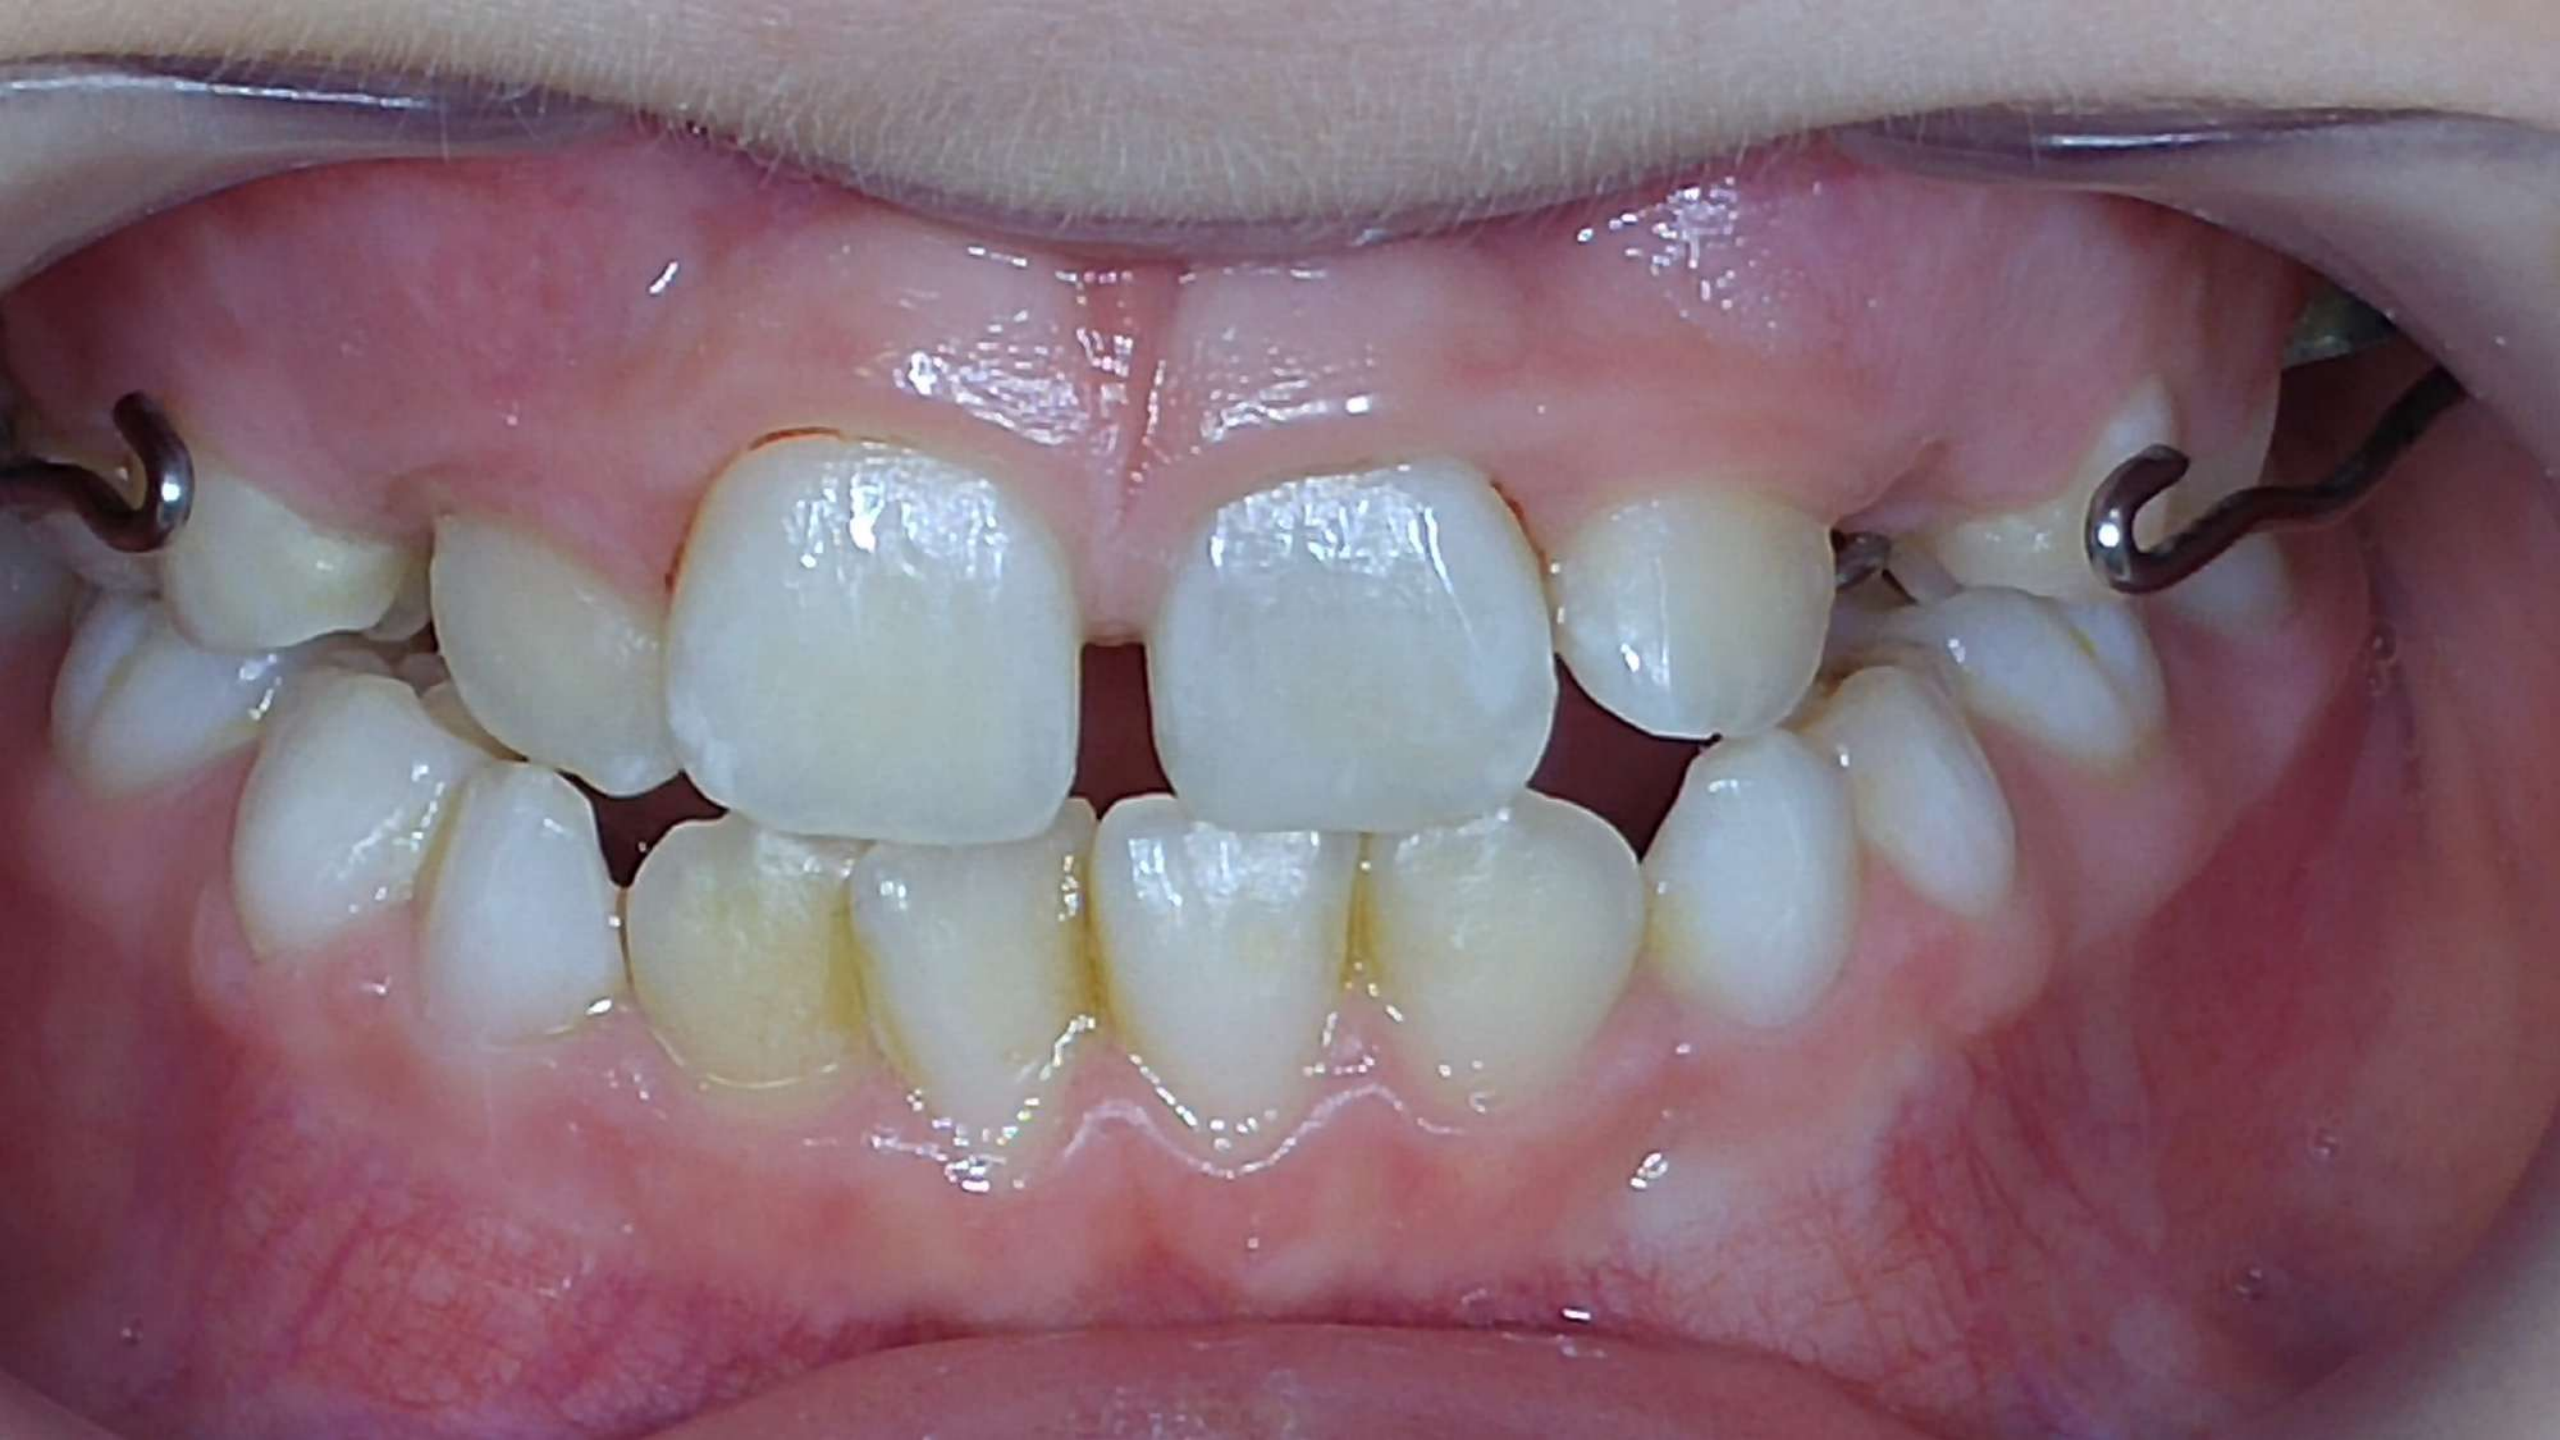
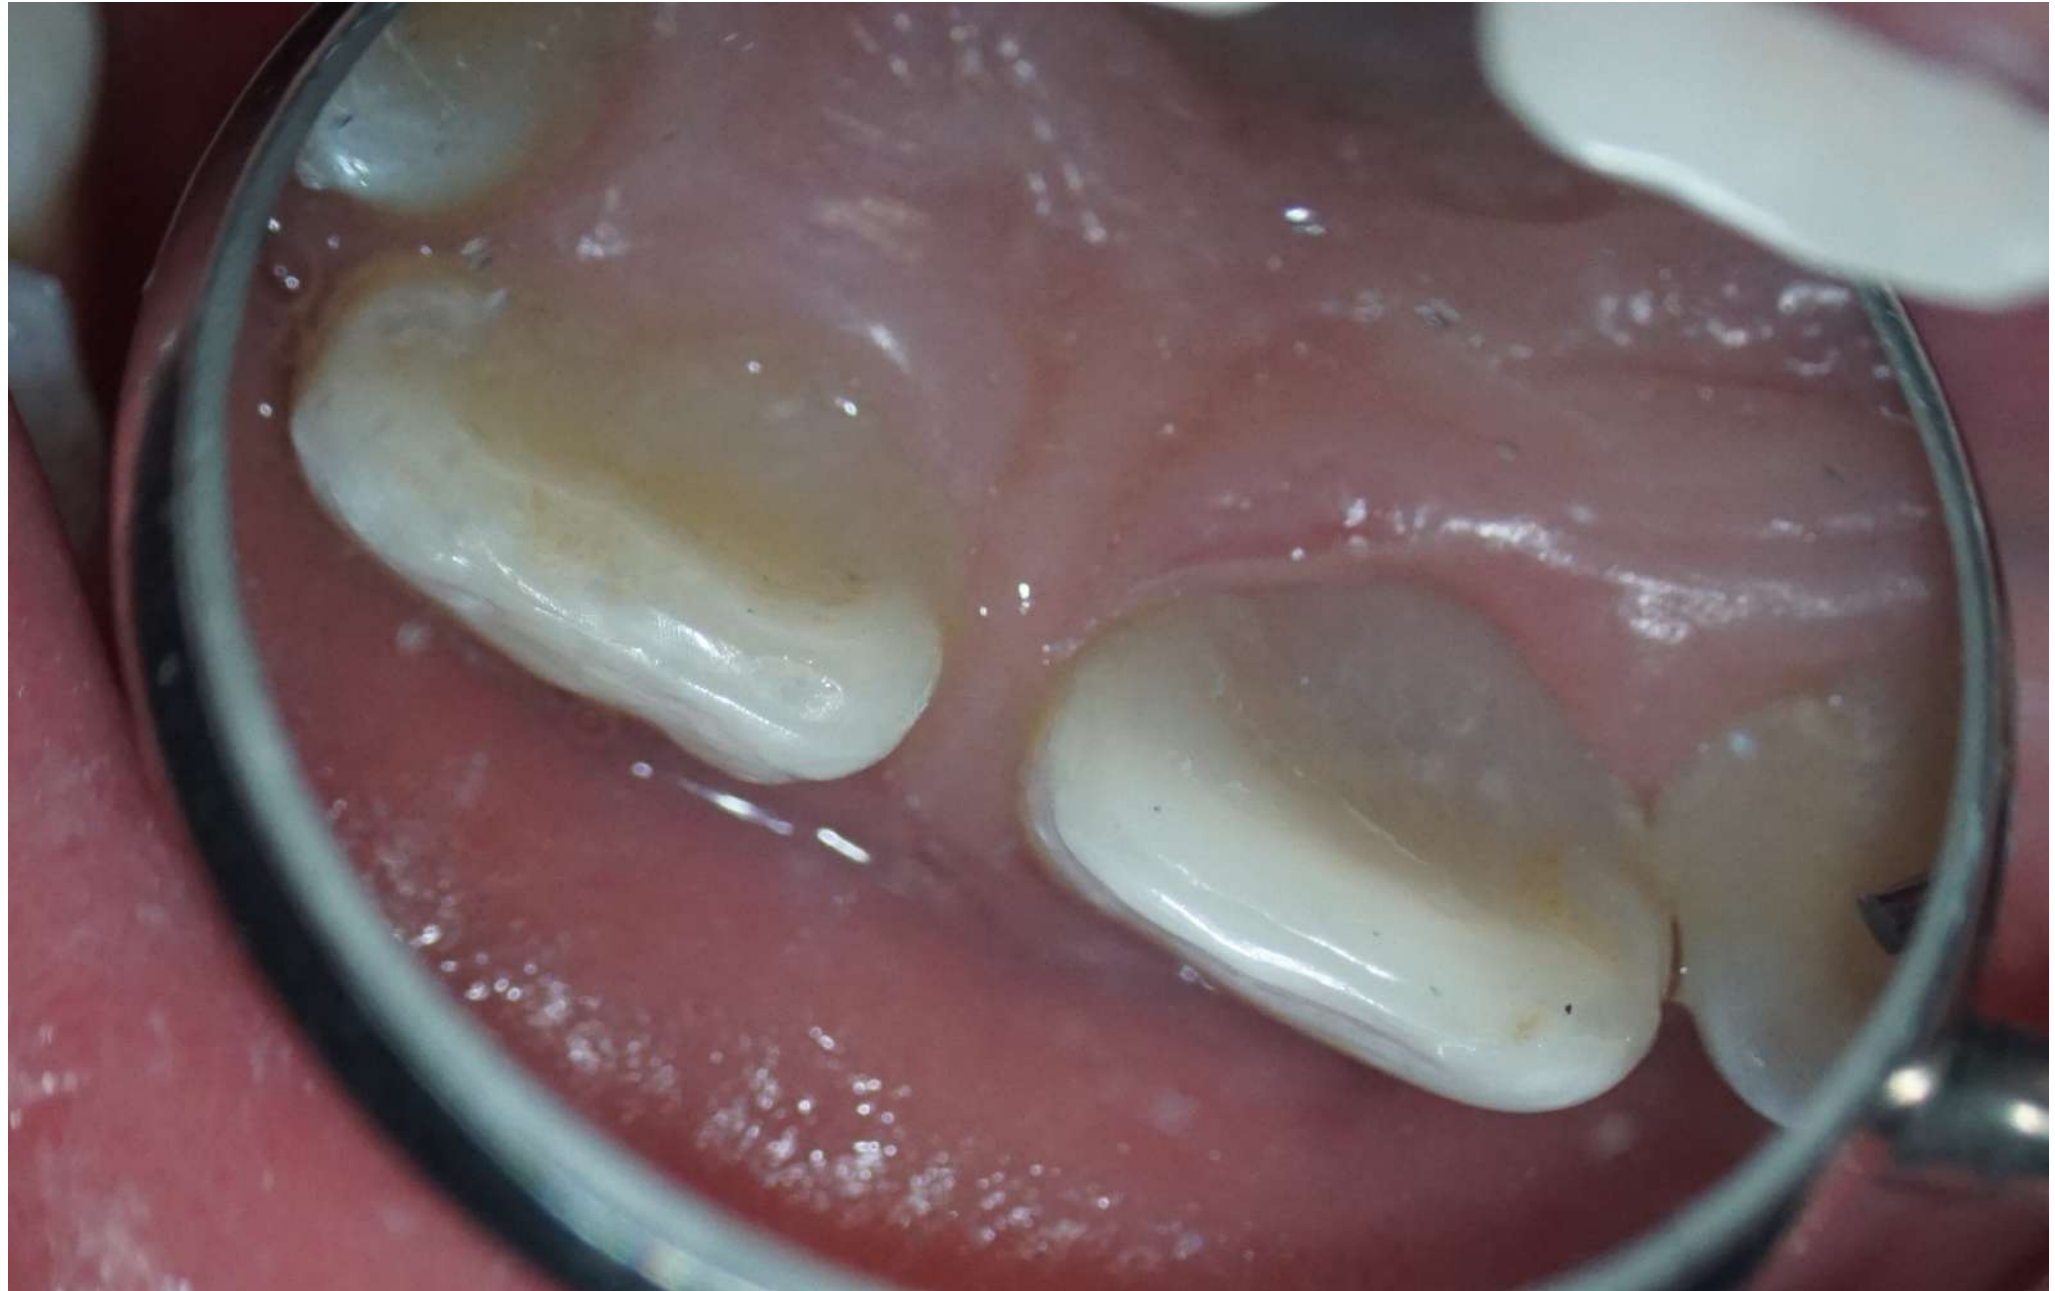
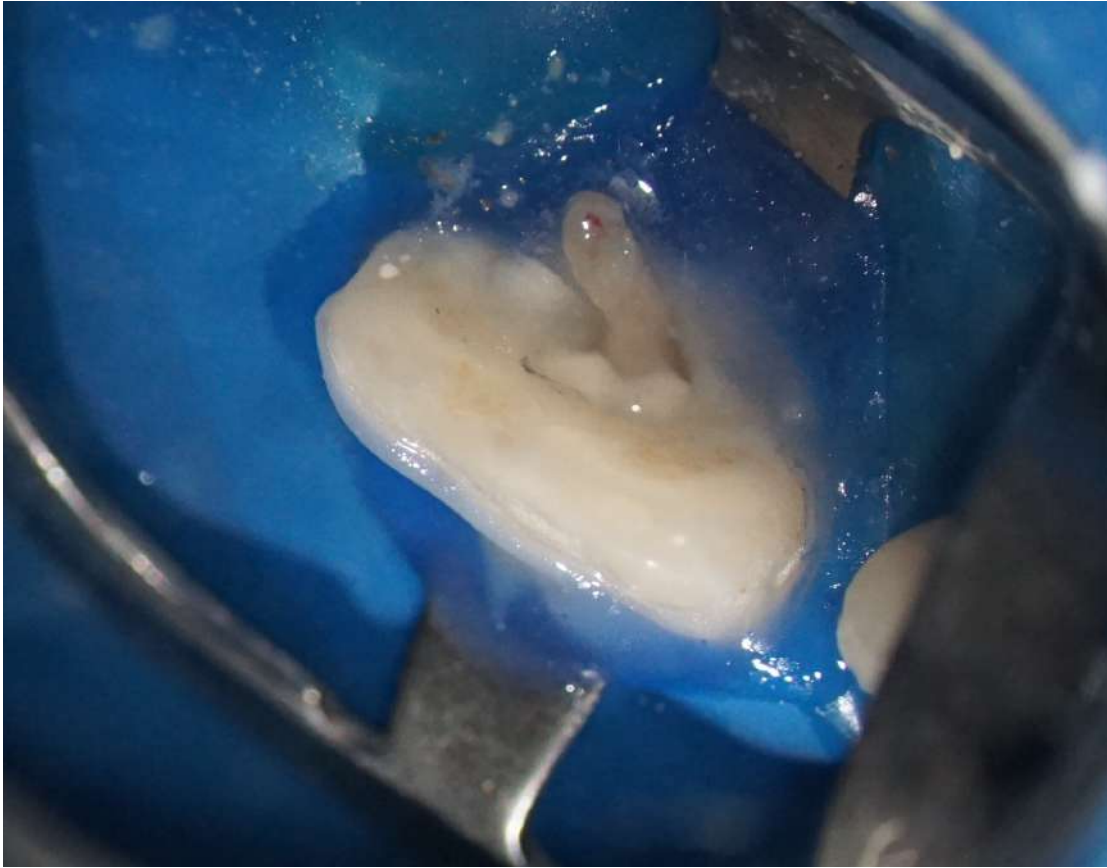
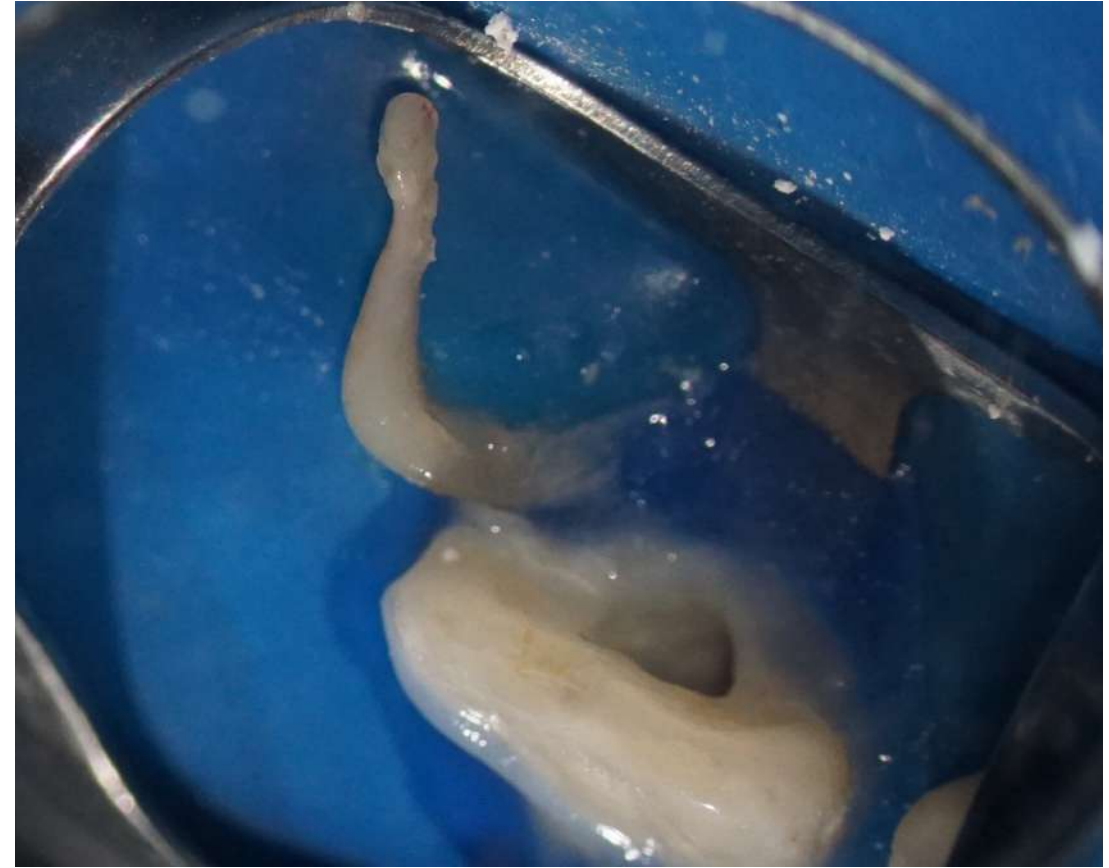
After opening the tooth chamber 11, the pulp was bleeding, shiny and expanded in the apical part, wich may suggest the beginning of the resorpive process.
