Immediate replantation

Gabriela Opolska

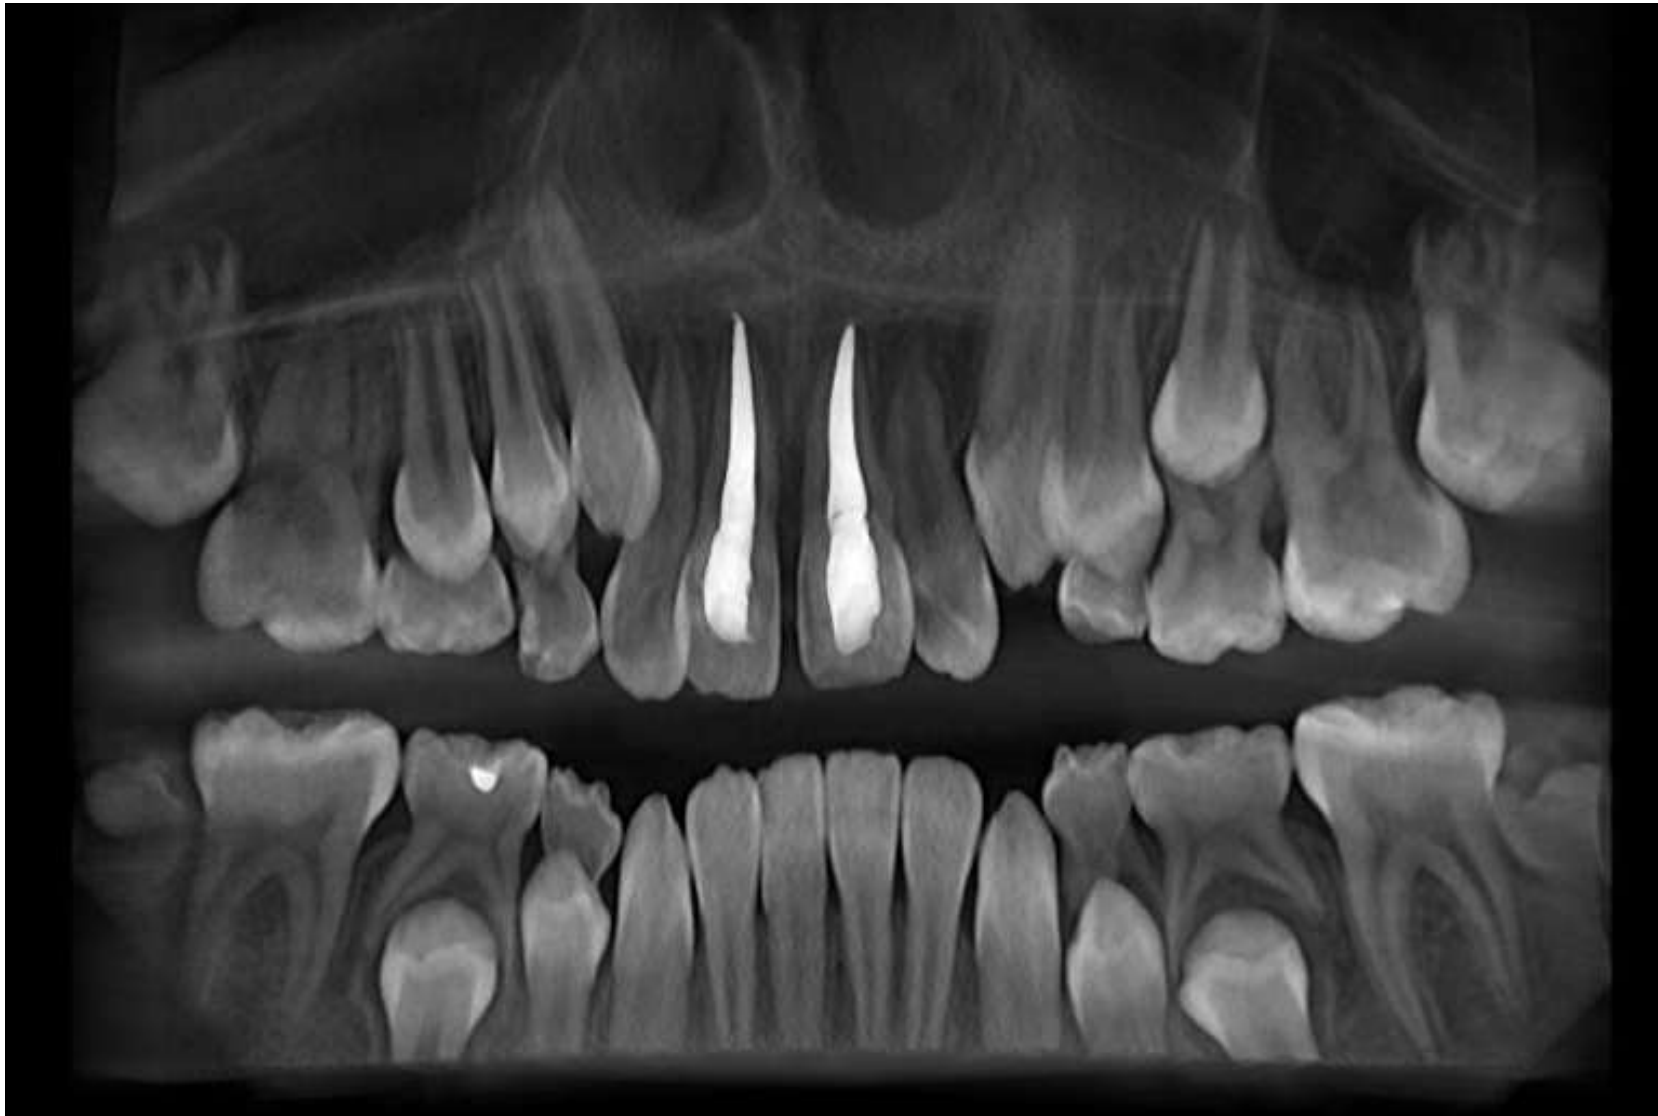
Follow-up after 1,5 year

CBCT FOV 5x5,5 cm Axoeos (Sirona)
